# Fractured Basalt Aquifer -- Four Mound Prairie

## Case Study 2 Fractured Basalt Aquifer – Four Mound Prairie, Northwest part of Spokane County, Washington

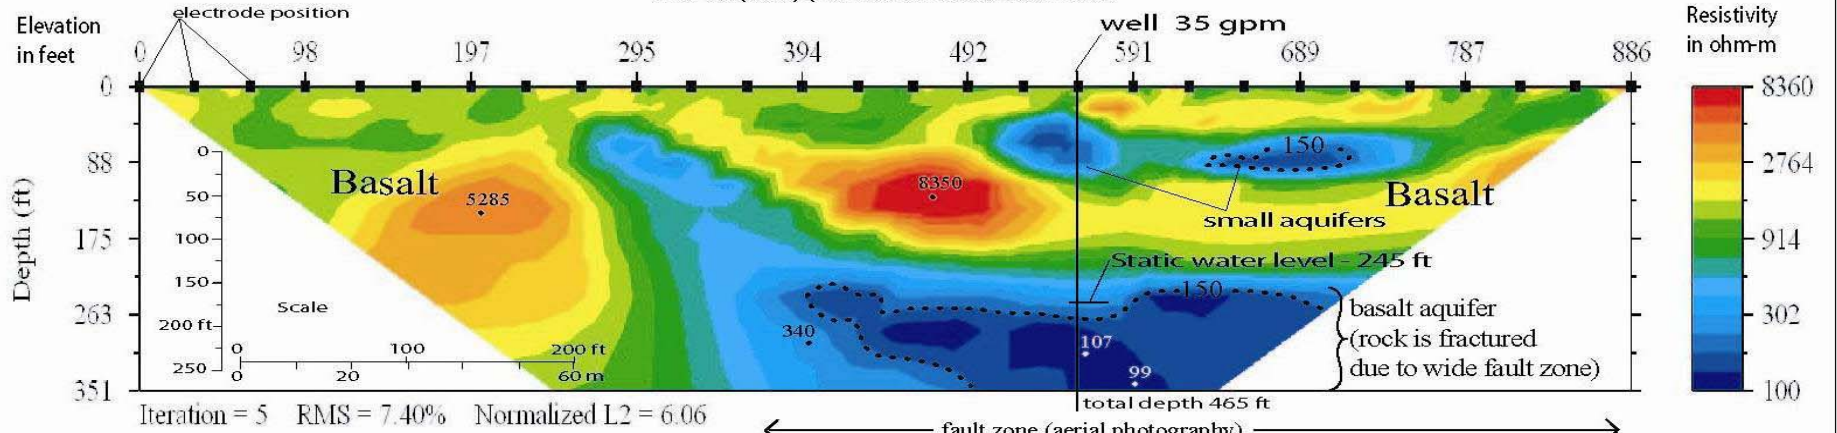
Line #3 (east) (horizontal distance in feet)

Client requested that the survey lines be located as near as possible to the residence, so lines #1, #2, and #3 were recorded accordingly with Line #3 purposely located to cross the position of the 35 gpm well (see electrode 18 on line #3 on *HydroImage profile*). The *HydroImage* profile of Line #3 shows that the area below 250 ft depth on the lower right of the profile is likely within the presumed fault zone. This zone contained the low resistivity values ranging 99-107 ohm-meters. This zone is responsible for the water-producing well. The static water level in the well is known to be 245 ft, an elevation that closely corresponds to the top of the low resistivity zone on *HydroImage* profile #3. The hypothesis developed from this work was that the fault zone was responsible for fracturing of the rock and the development of the aquifer located at this well.

**CONCLUSION**—Five *HydroImage* lines recorded in July 2006 did not locate a site for drilling of a well on the client’s property. Because the imaging work encountered no targets in an area that previously recorded 12 dry wells, it was recommended that the client arrange to share the water supply from the well located on the neighbor’s property. Location of this well that produces 35 gallons per minute (gpm) is shown on the profile of line #3. This recommendation resulted in saving the cost of drilling of another unsuccessful well (dry hole).
